TECHNICAL BULLETIN

Diesel Engine/Fuel Tank Preventative Maintenance

Bulletin #:	Rev:	Created by:	Date:
83629	-	RZV	FEB 8, 2012

ECR # 16669

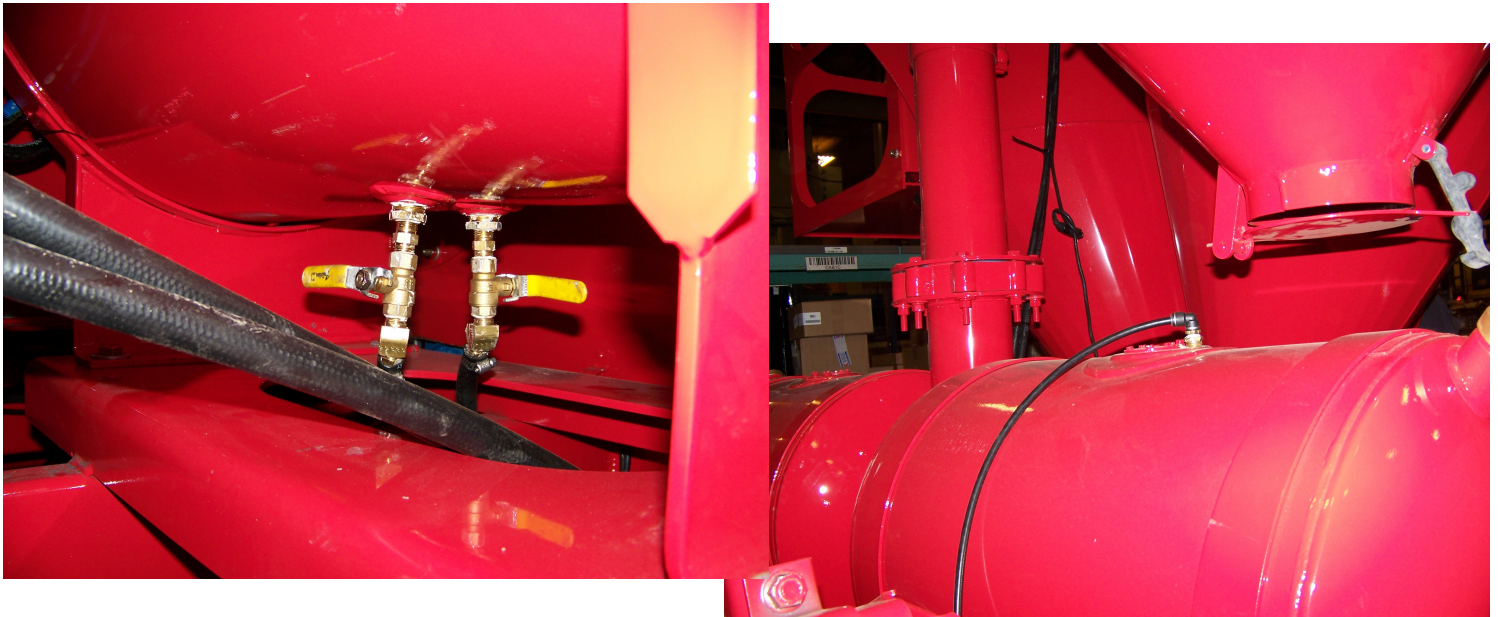
Engines installed between Aug 2010 and Jan 2012 have been failing due to insufficient line size going to and from the fuel tanks. At the recommendation of the engine supplier, a couple of things should be done to stop this from happening in the future.

See images of the corrections that need to be made.

1. Return line should go into the secondary tank not the primary tank.
2. Return line should be 3/8" instead of the 1/4" line.
3. Line connecting the tank to the engine should be a 1/2" line instead of 3/8".
